PROPERTY INSPECTION REPORT

**Earl Hughes License #22331
Top Choice Inspection**

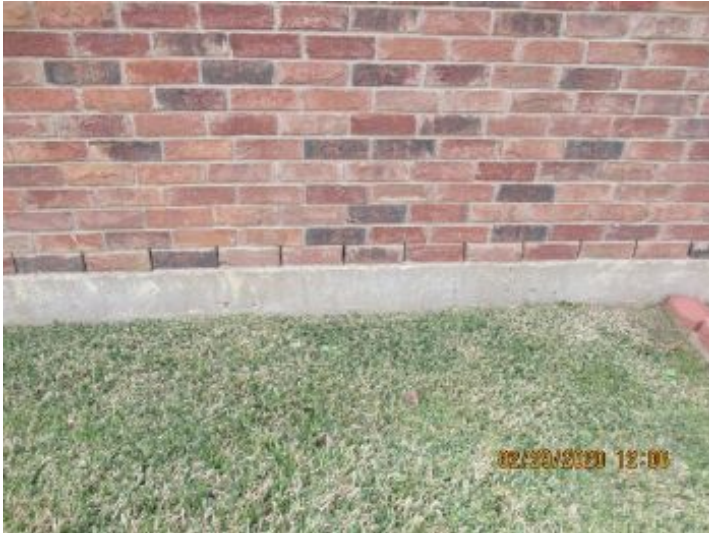
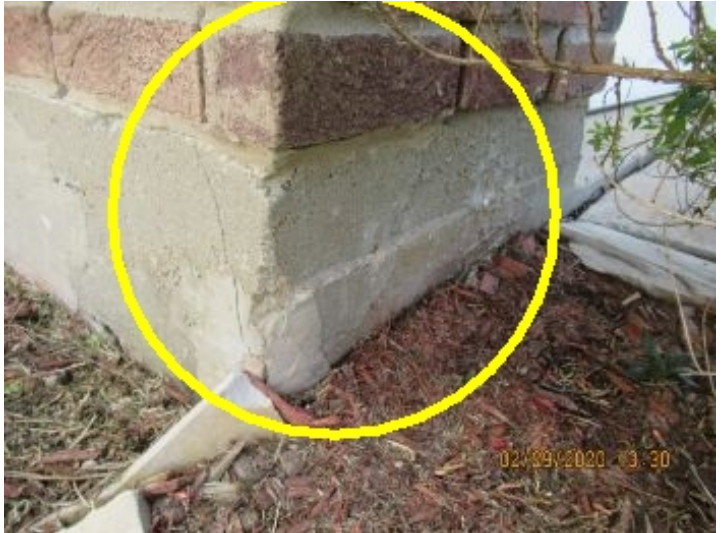
This post tension slab appears to be functioning as intended at the time of the inspection.

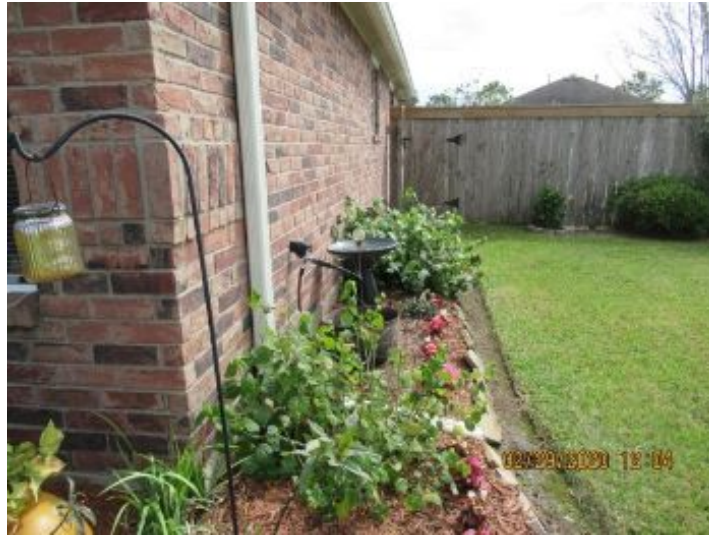
Grading and drainage appears to function as intended at the time of the inspection but this wall also has foliage growing against it that should be trimmed.

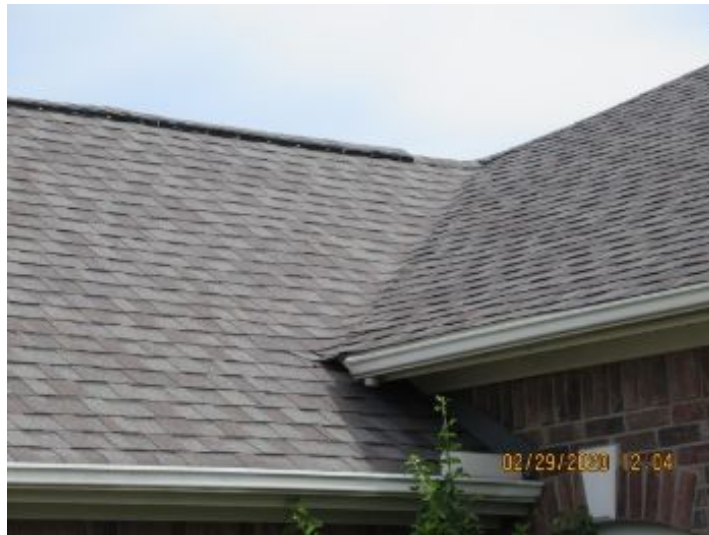
Roof is approximately one year old and appears to function as intended at the time of the inspection.

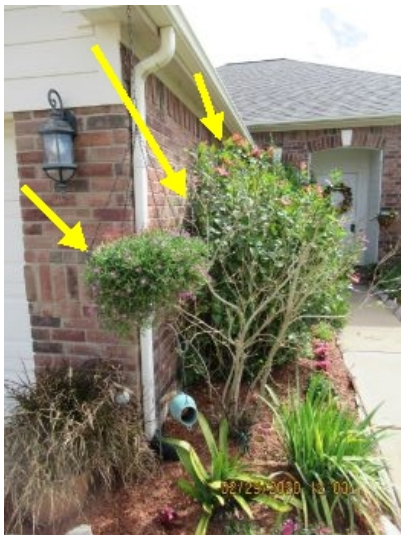
All foliage should be trimmed away from the exterior veneer 18" to allow for air circulation to allow moisture evaporation.

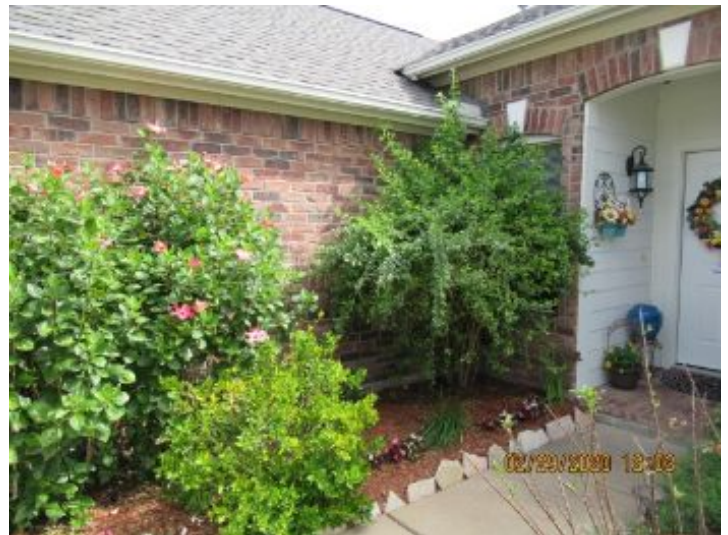
Another view of foliage that needs to be trimmed to allow air circulation between the bushes and the brick.

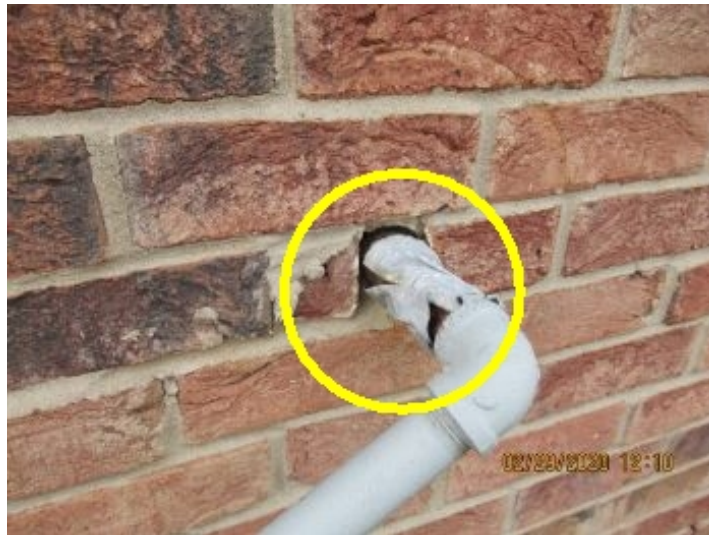
Wall opening needs to be sealed.

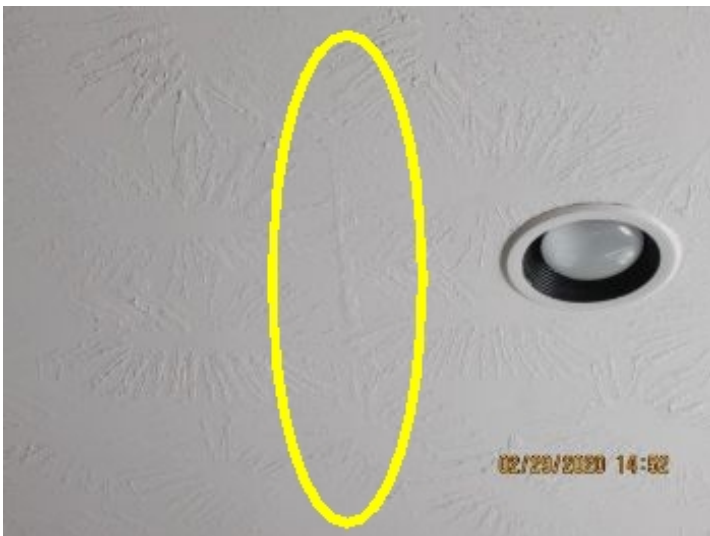
This is a small crease in the breakfast room ceiling that is typical of a past water leak or sheetrock movement.

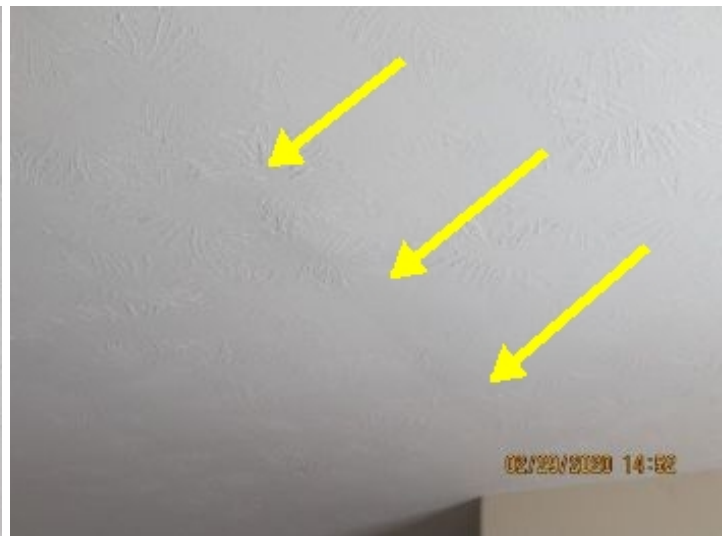
This is a belly in the ceiling between the den and the breakfast room ceiling that is also evidence of a past water leak. I was told the roof was replaced last year.

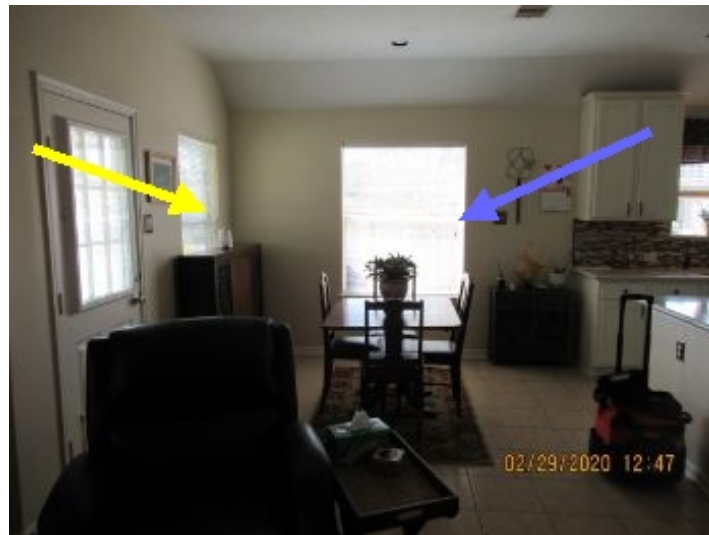
These windows are hard to operate. The blue arrow points to a hard to open and close/lock one. The yellow arrow points to one that I could get open but could not get it down far enough to close and lock.

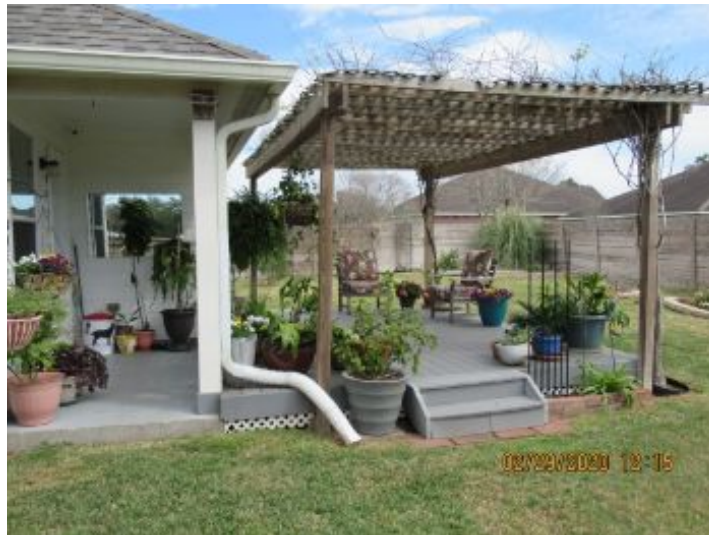
This is a good picture showing the patio cover is not attached to the home nor is the deck. Both appear to function as intended at the time of the inspection.

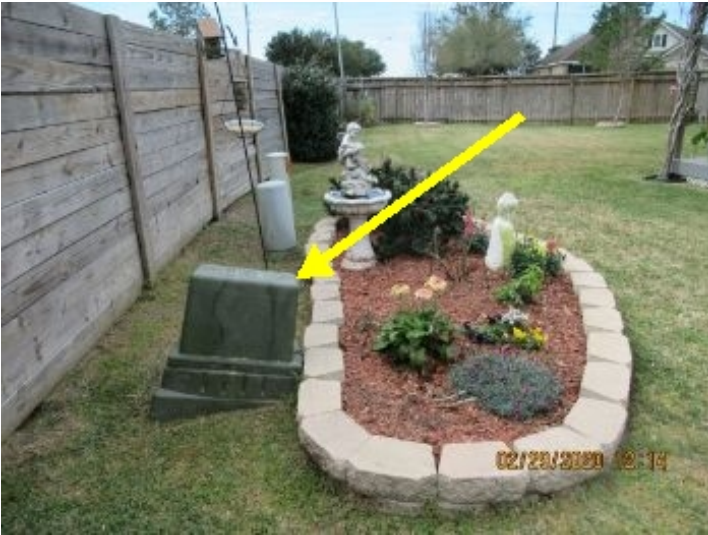
This is the underground feed for the electrical power for the house.

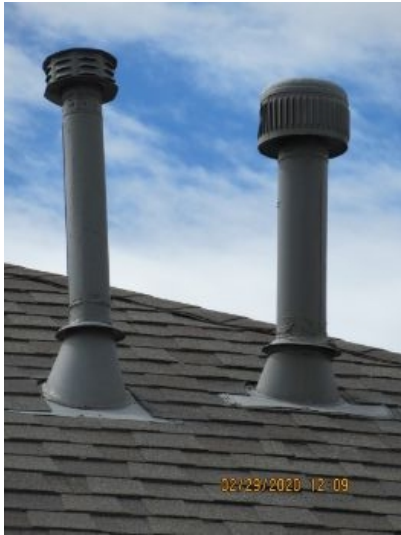
The roof vents appear to be functioning as intended at the time of the inspection.

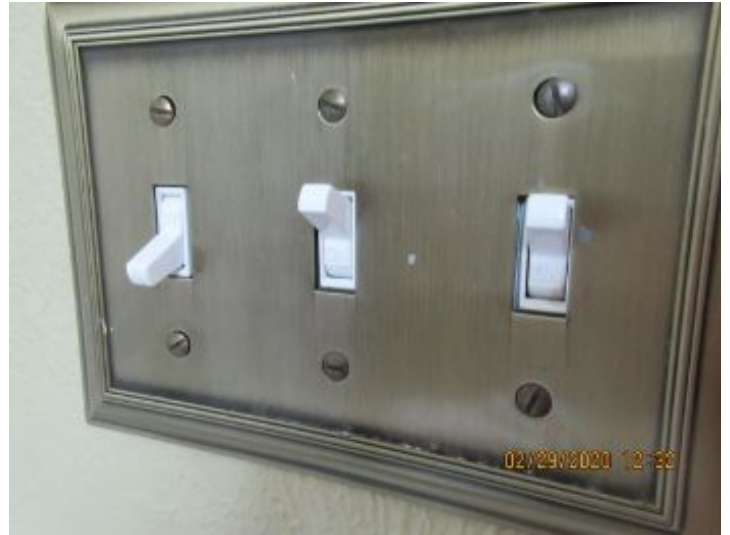
The middle switch of the hallway bathroom gives power to a humidity controlled exhaust fan.

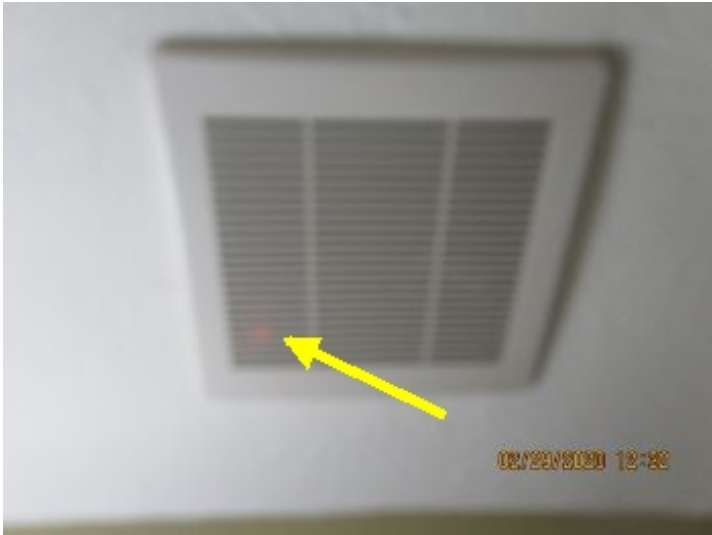
This is the humidity controlled exhaust fan. You can see the faint orange color that shows it is running. When powered but not running, the light will be blue.

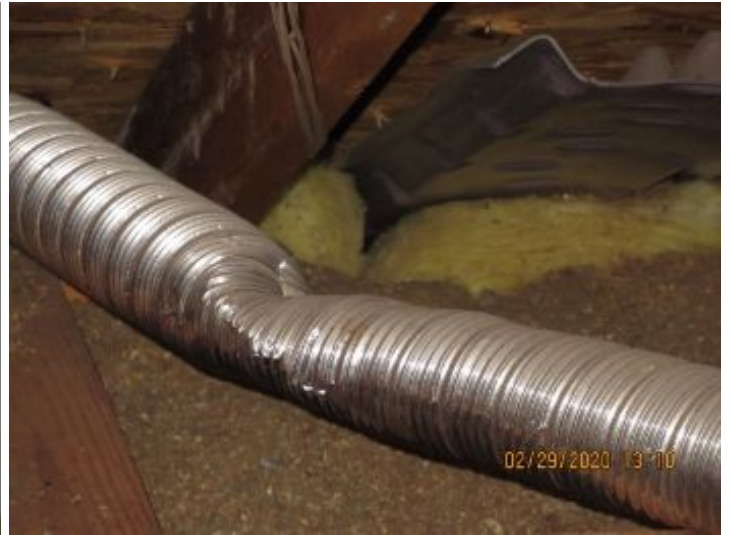
This ventilation piping is bent and should be repaired and/or replaced.

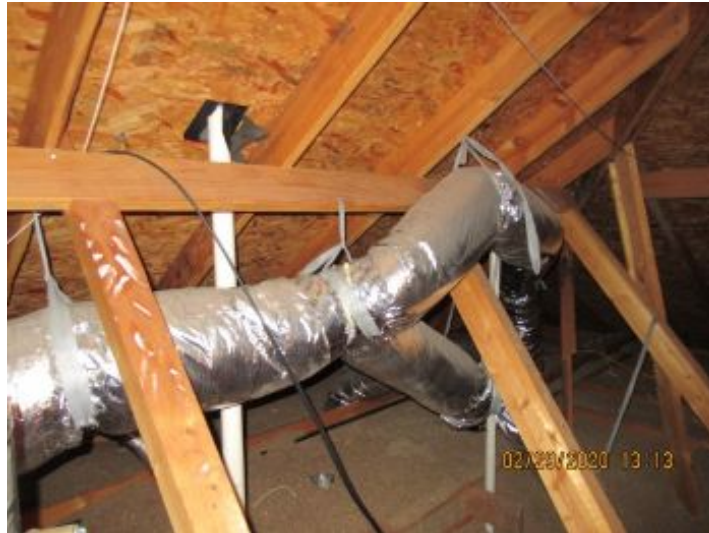
Ductwork is supported as suggested and appears to function as intended at the time of the inspection.

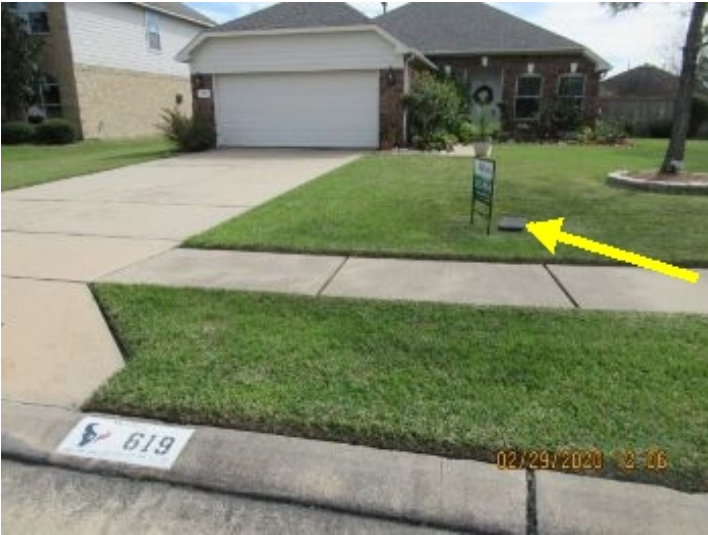
Water meter location.

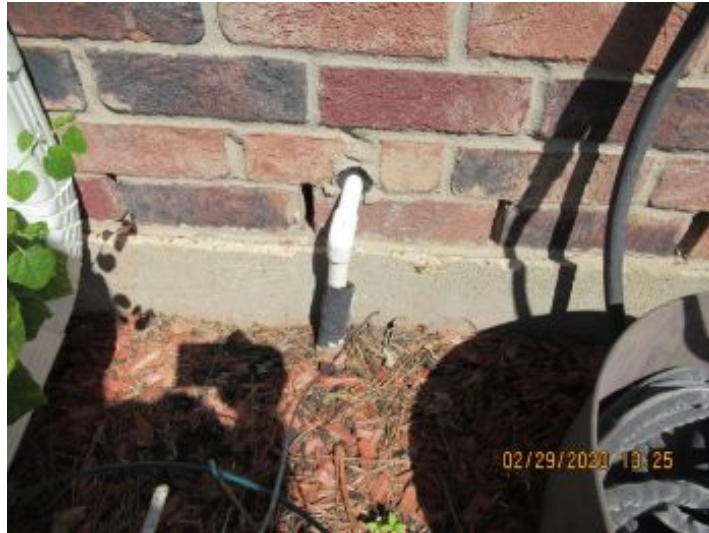
This piping is missing insulation.

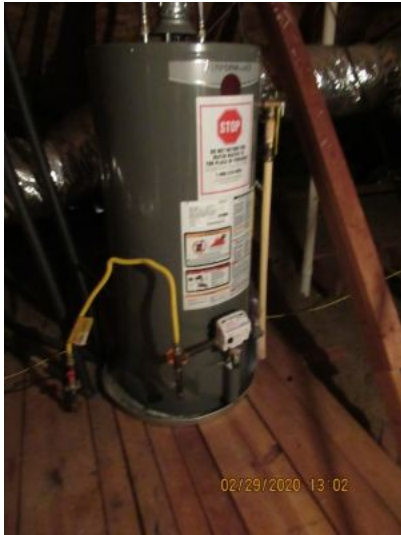
New 40 gallon Rheem water heater installed and functioning as intended at the time of the inspection.

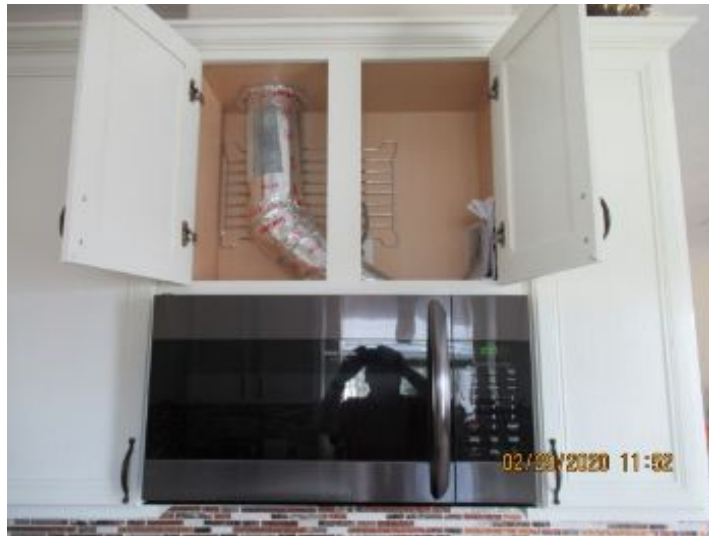
F. Mechanical Exhaust Vents and Bathroom Heaters

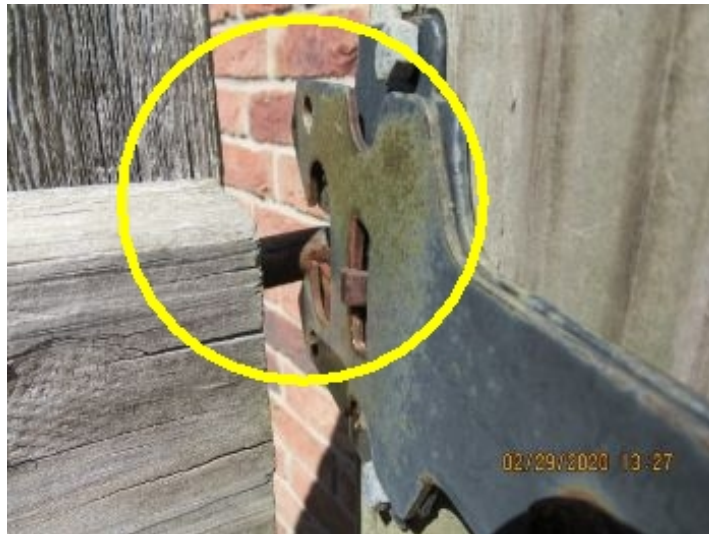
The latch on the gate is hard to lock and should be fixed or replaced.
